Danielle Lacko
MEP-200-01
March 30, 2001

The Eastland Steamer

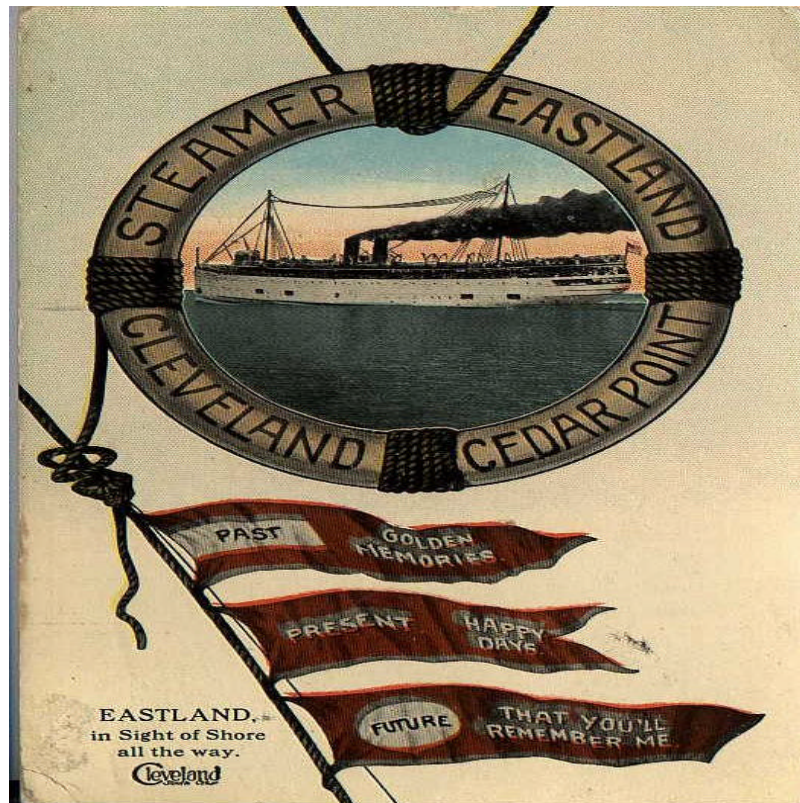
“Photos.” Chicago Historical Society. 1998-2001
<<http://www.eastlanddisaster.org/postcards.htm>>
